PHOTOGRAPHIC INTELLIGENCE REPORT

HA TOU NAVAL SUPPORT FACILITY
HA TOU, NORTH VIETNAM

CIA/PIR77142

DATE MAY 1967

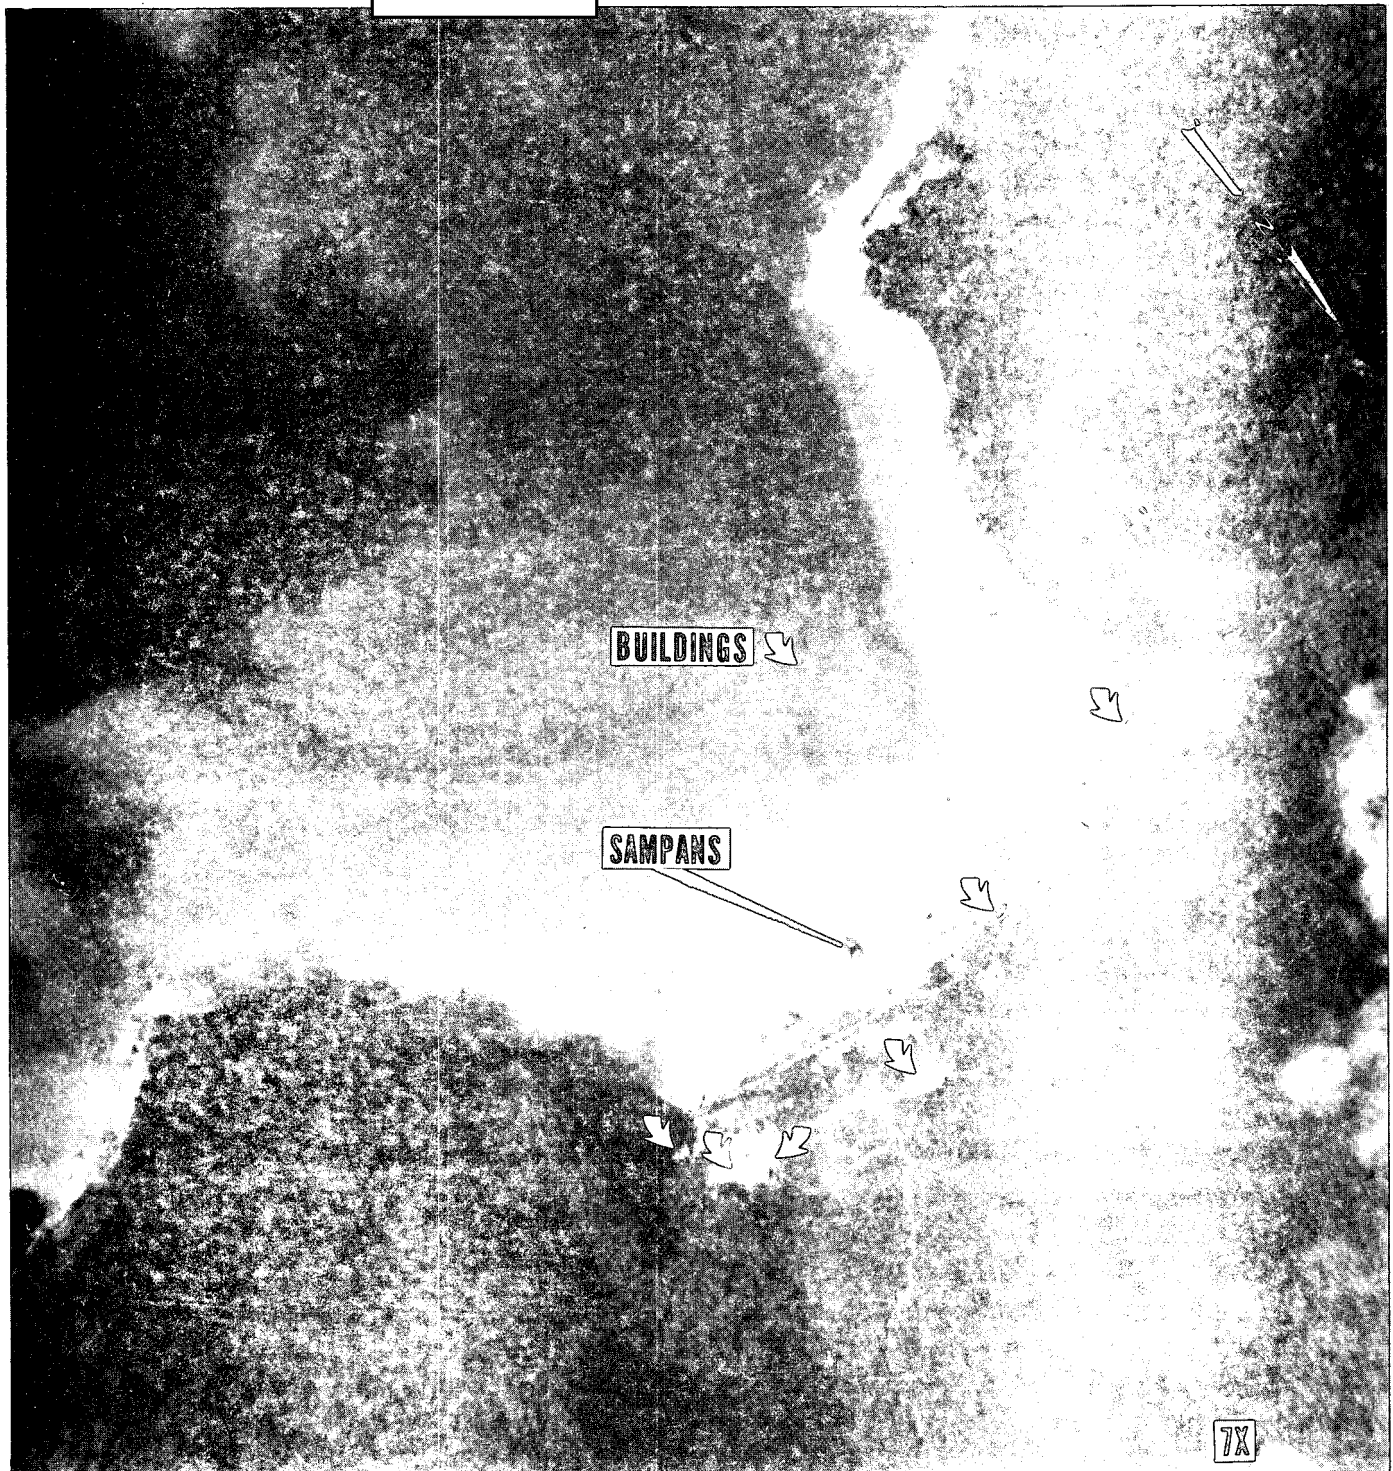
FIGURE 2

The Ha Tou Naval Support Facility consists of six scattered buildings. The area shows very little activity, and no construction equipment is observed. Several sampans are anchored near shore (see Figure 2).

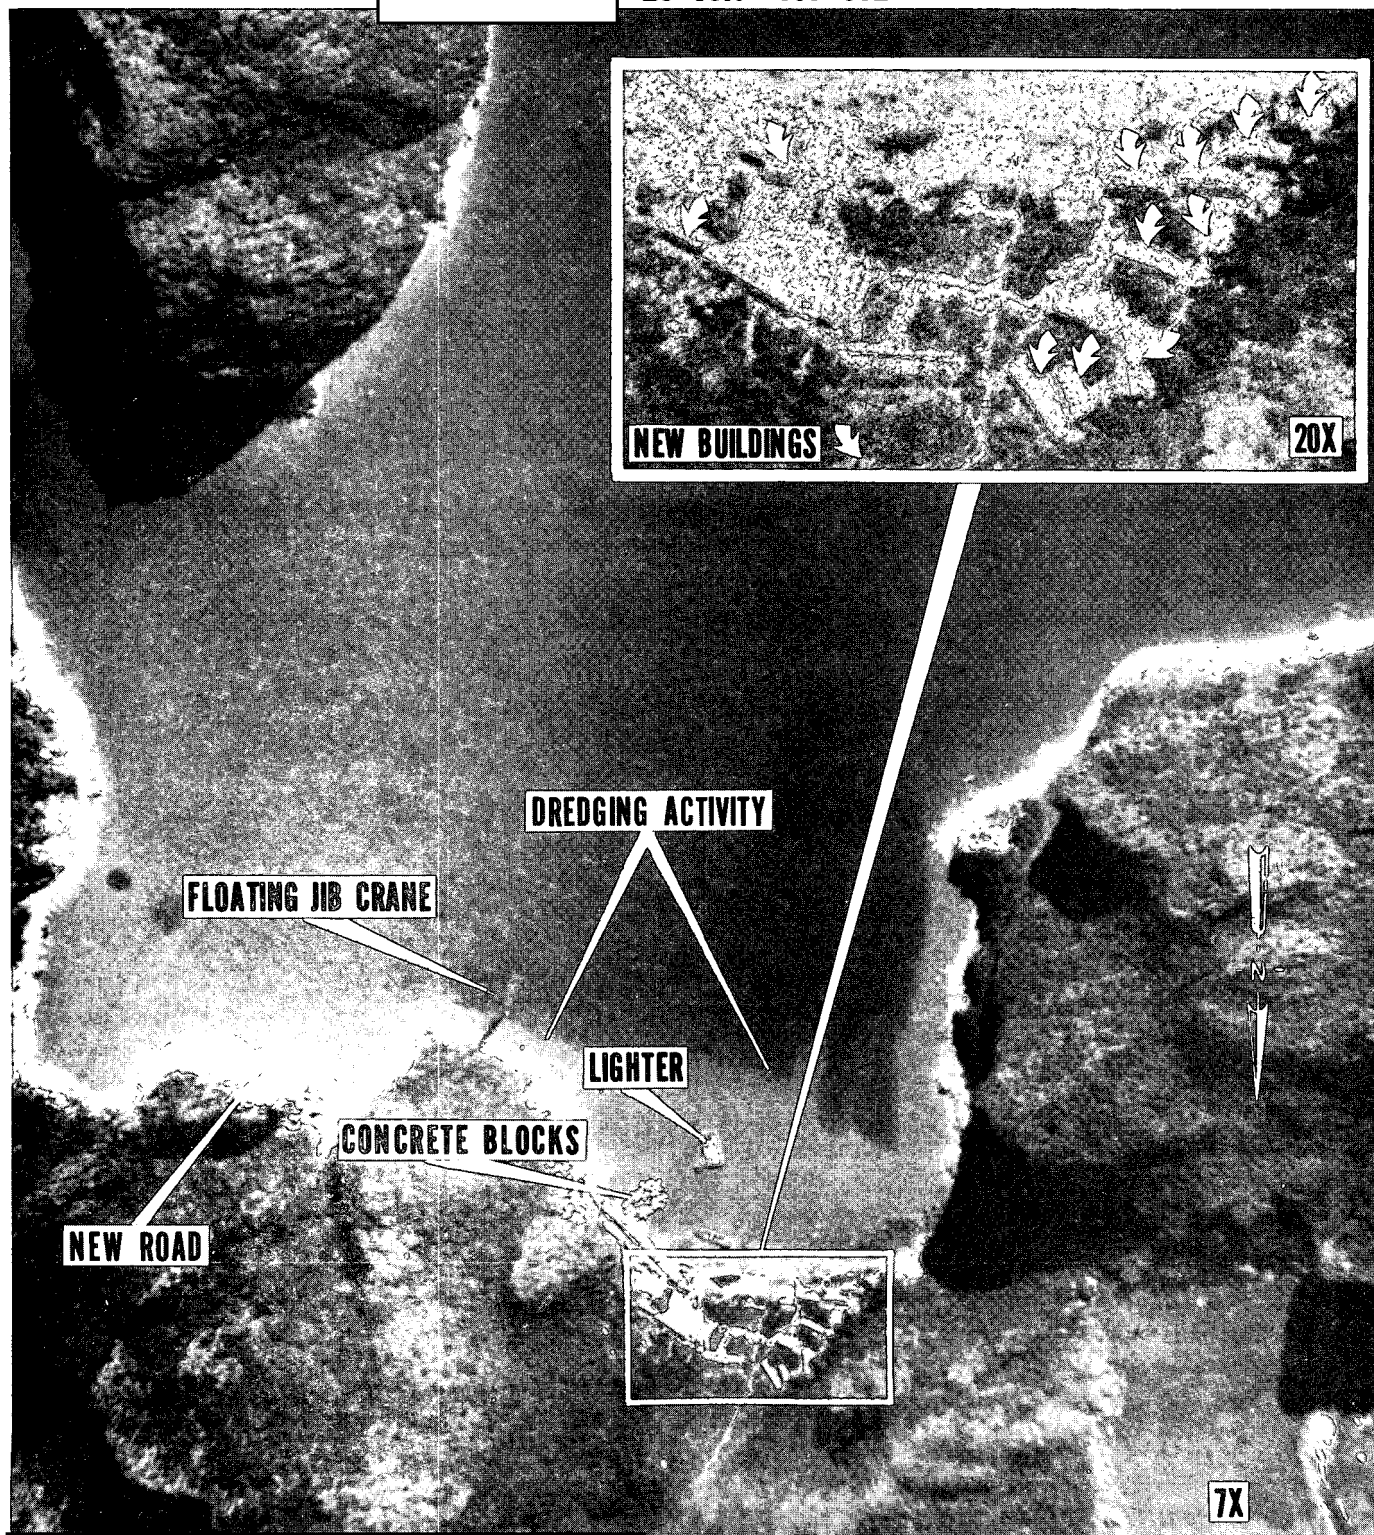
FIGURE 3

The Ha Tou Naval Support Facility consists of 17 buildings, an increase of 11 buildings in five months.

The area shows a significant increase in activity. Dredging of the bay is underway, and a new road has been constructed along the shore line east of the facility linking it with a large storage area. A pile of concrete blocks has been dumped near the shore and a filling operation appears to be taking place at the eastern edge of the installation. A floating jib crane is also located in this area; however, its purpose there is not known (see Figure 3).

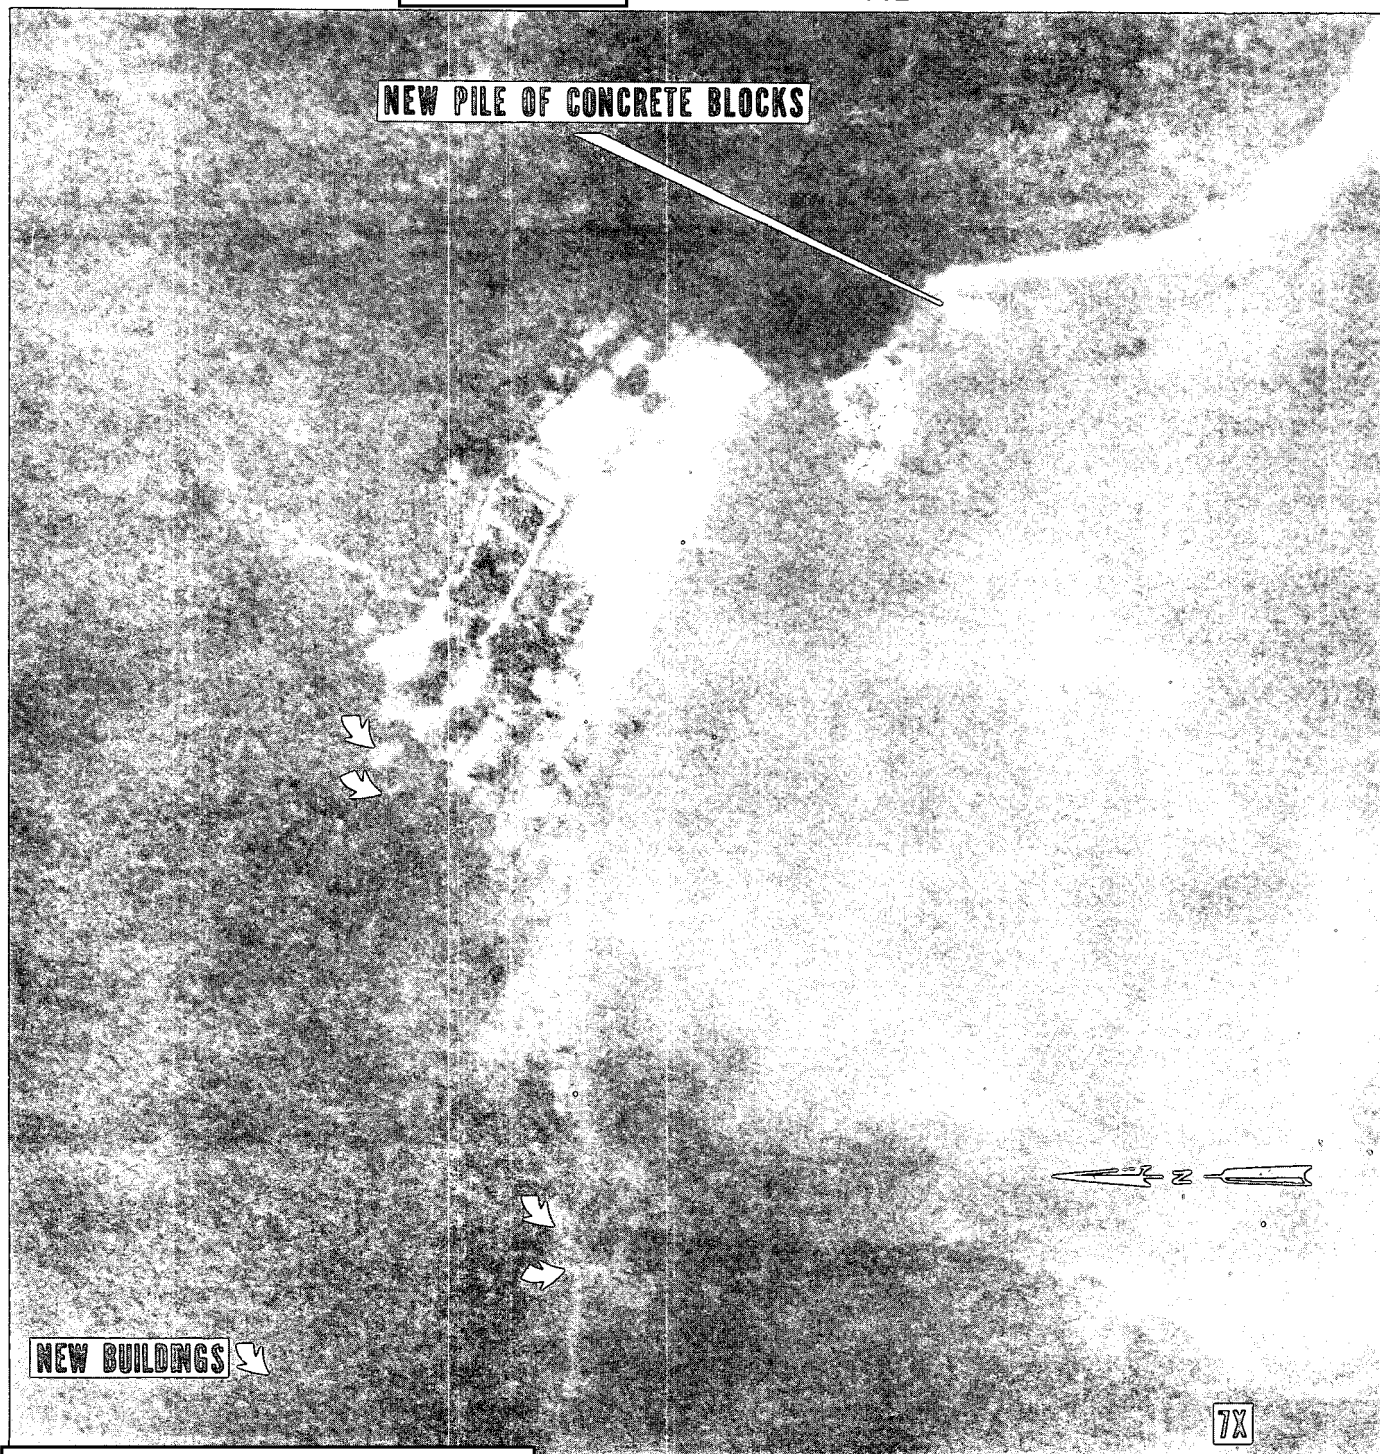
FIGURE 4

The Ha Tou Naval Support Facility consists of 21 buildings, an increase of 4 buildings in [REDACTED] time.

The area shows a decrease in overall activity except for the addition of another pile of concrete blocks. No construction or dredging activity was observed (see Figure 4).

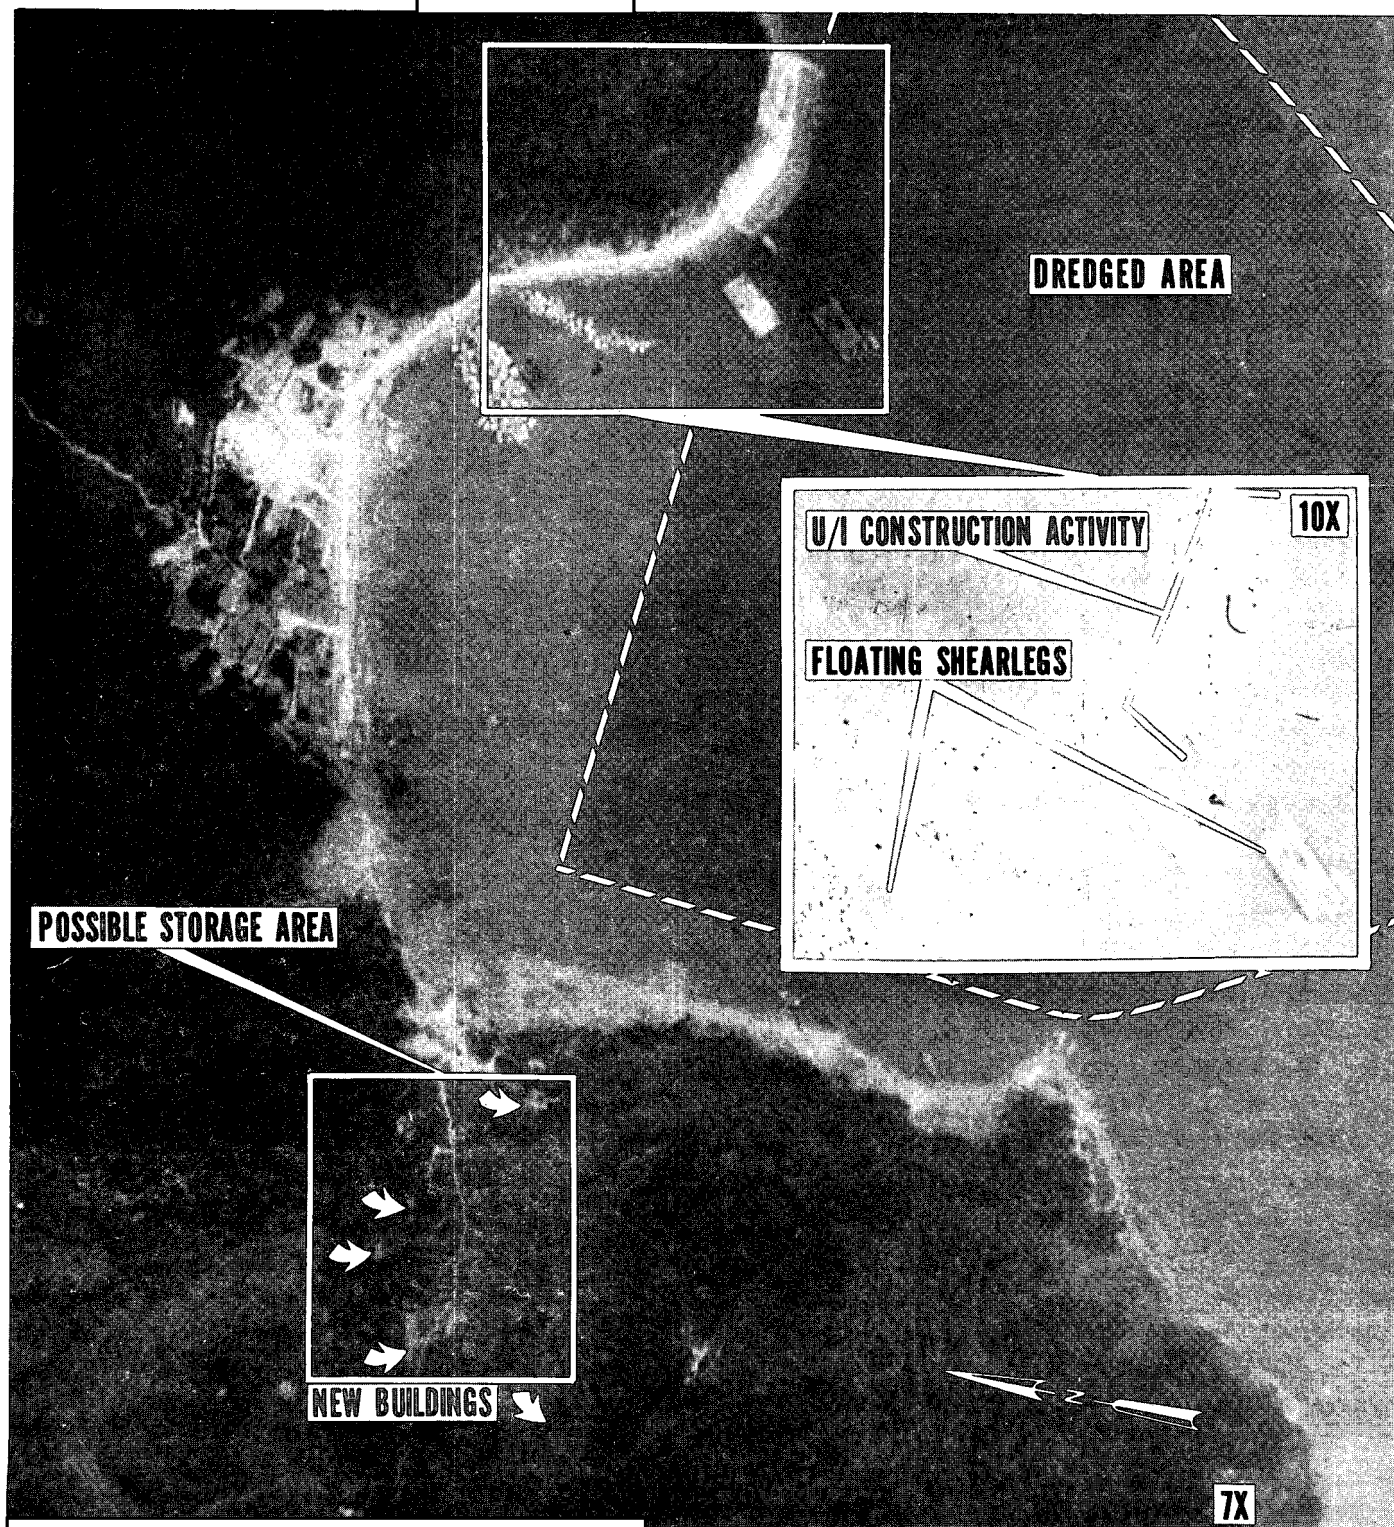
FIGURE 5

The Ha Tou Naval Support Facility consists of 25 buildings, an increase of 4 buildings in six months time. These buildings comprise a possible storage area.

The facility shows an increase in activity

The number of concrete blocks has increased, and two floating shearleg cranes are present. The dredging activity has deepened a large area in the bay, and it appears the dredging is complete. Filling operations in the area on the eastern edge of the installation also appear to be complete.

In general the activity appears to be in a state of transition between basic preparation of the area and construction of the particular port facilities (see Figure 5).

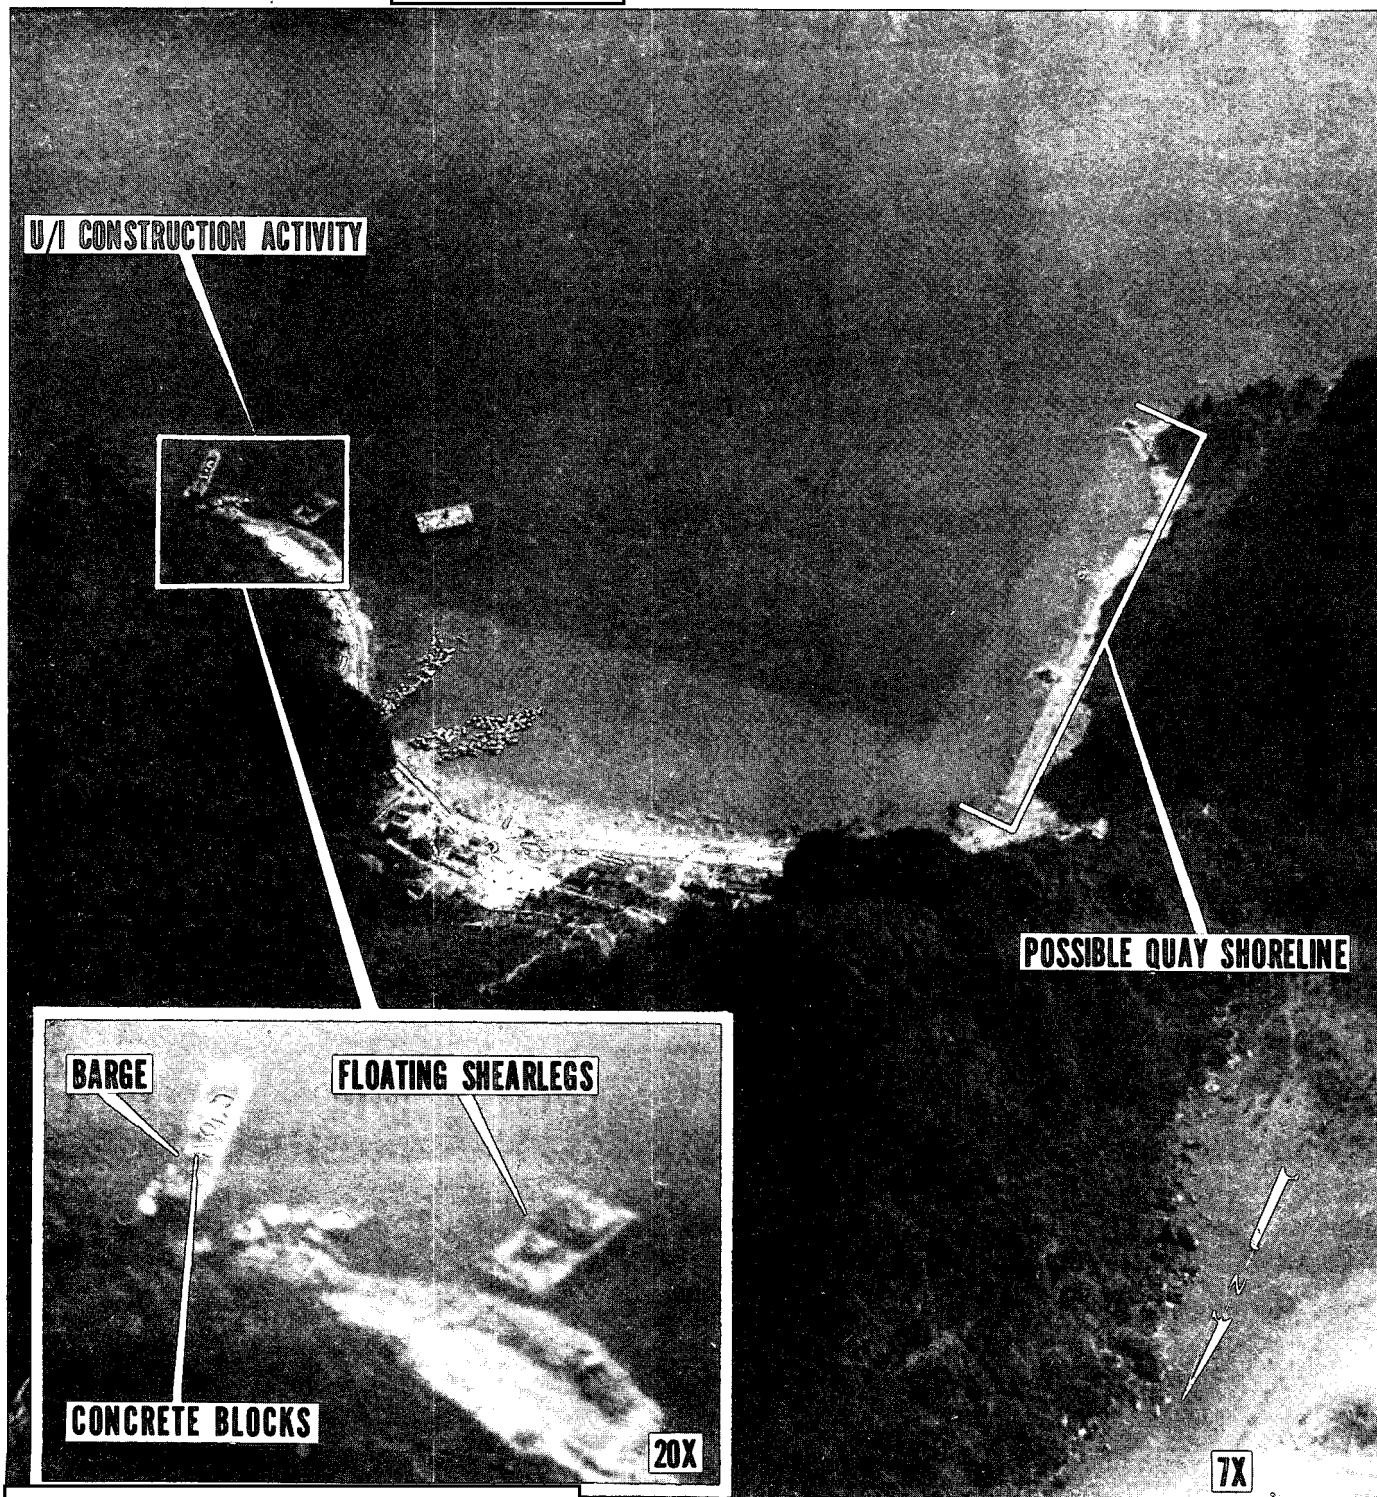
FIGURE 6

The Ha Tou Naval Support Facility shows no change in the number of buildings

The area shows an increase in activity which appears to be related to construction of the port facilities. The shore line in the western edge of the installation has been straightened and has the appearance of a quay. The area east of the installation, in which filling had occurred, appears to be ready for construction. A floating shearleg crane and a barge are being used to move the concrete blocks to this area. The exact use to be made of these blocks is as yet undetermined (see Figure 6).
